ELECTRIC SHOCK DROWNING: THE INVISIBLE KILLER!

Colorado River Law Enforcement Association (CRLEA) Conference

Created and Presented By

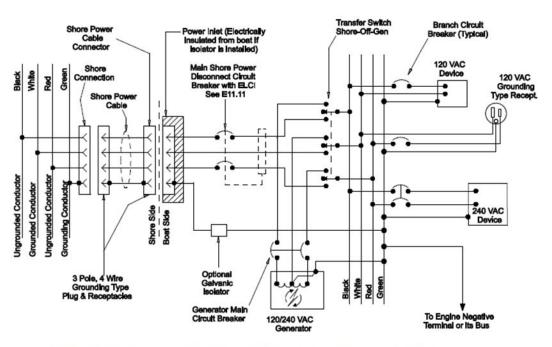
DIAGRAM 4 - Single Phase 120/240 Volt System with Shore Grounded (White) Neutral Conductor and Grounding (Green) Conductor (see <u>E-11.17.2</u>).

NOTE: This diagram does not illustrate a complete system. Refer to appropriate text.

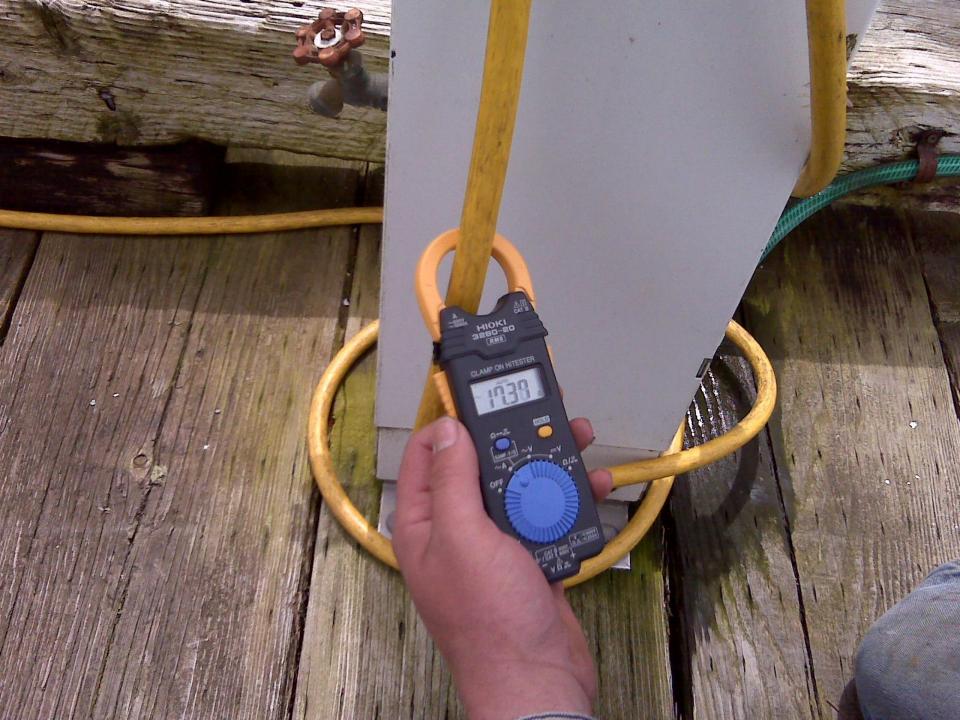
Clamp Meter Use:

- Current in the shore power cord goes into the boat on the cord's "hot" conductor, and comes out on either the cord's return "neutral", its "safety" return green wire, or both.
- Clamping the entire shore power cord tells whether or not the boat's AC system is putting current into the water.
- Here's Why: The in-bound magnetic field created on the AC "hot" conductor must equal the out-bound magnetic fields created on either, or both of the returning conductors. If the fields are equal, then there is no lost current and the clamp meter reading is zero.
- Any reading other than zero identifies the amount of current that is using the water as a return path.

- Clamp one, and then the other
- If you get a reading, clamp both together
- If you then still get a reading, you have a leak of that magnitude
- If you are unable to clamp both for some reason, record the two readings and subtract them; the result should be zero. If it is not, you have a leak of that magnitude
- Possibility of two separate systems

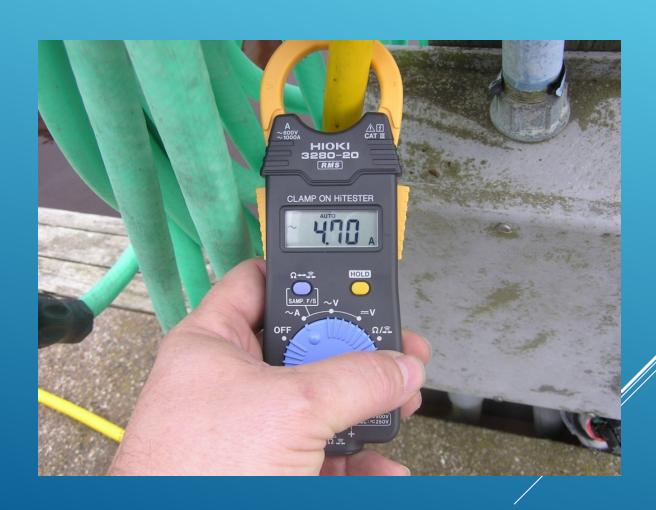
IS THIS A LETHAL BOAT?

- Clamping shore power cords for <u>current</u> in the water.
- Readings of 1 amps or greater present a dangerous condition and immediate action should be taken.
- Readings less than 1 amps are still serious, should be considered a threat to someone in the water, and should be checked by an ABYC certified marine electrician.
- Remember: AC current <u>must</u> return to its source and it will take all paths to get there.

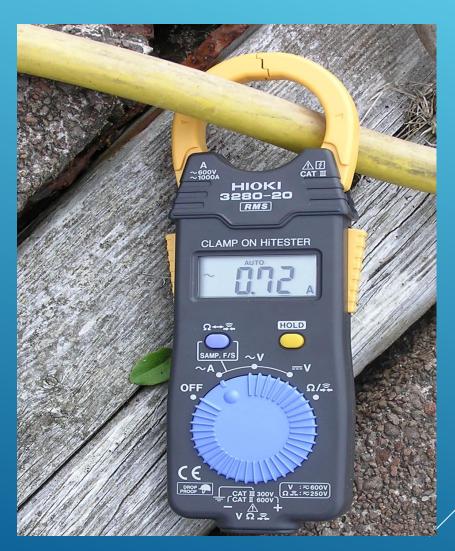
WHAT ABOUT THIS ONE?

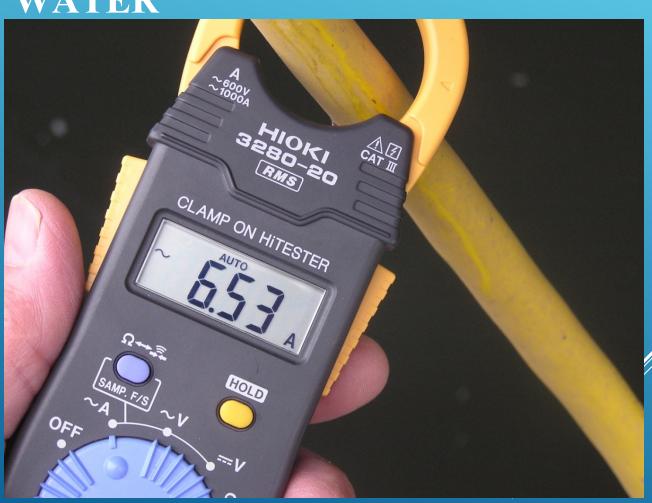
EXTREMELY LETHAL IN FRESH WATER

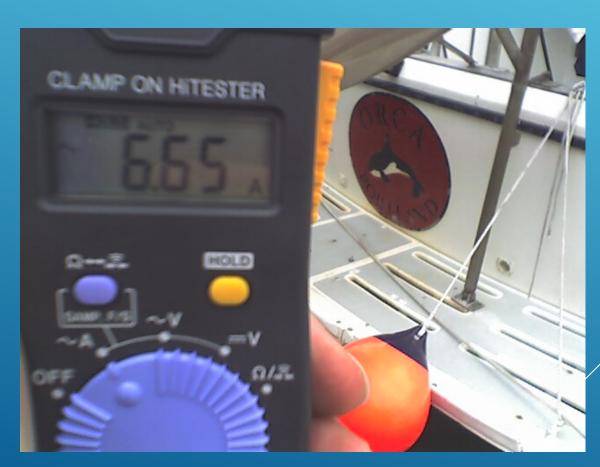
THIS IS IN SALT WATER... IS THIS LETHAL?

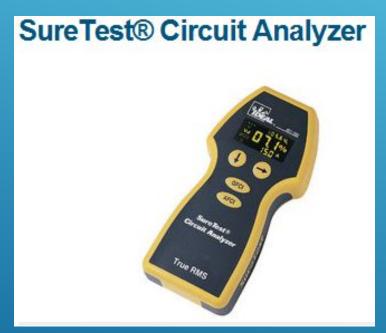
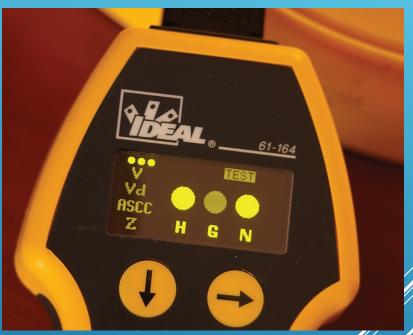
VERIFY YOUR GROUND

- > The AC voltage can be easily tested and documented using a probe.
- This is accomplished by placing a meter, in line, between the water probe and the dock ground.
- > Always test ground integrity.
- > As the probe approaches the source, voltage will increase.
- > Be sure that each AC component on-board, or on the dock, that cycles (i.e., sump pumps, battery chargers, water heaters, space heaters, etc.) cycles while the water is being probed.

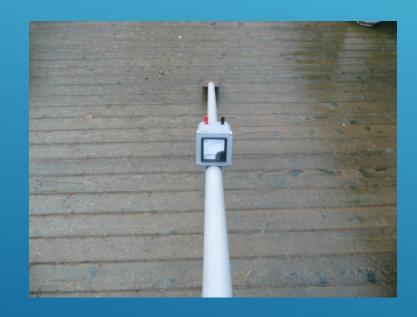
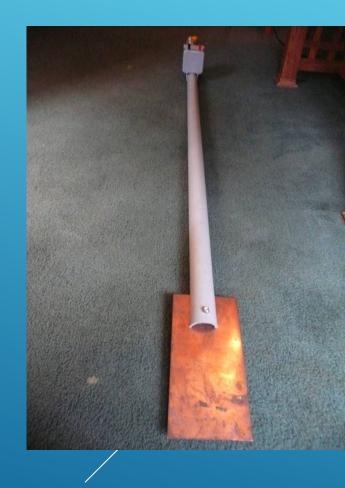
AC VOLTAGE PROBE

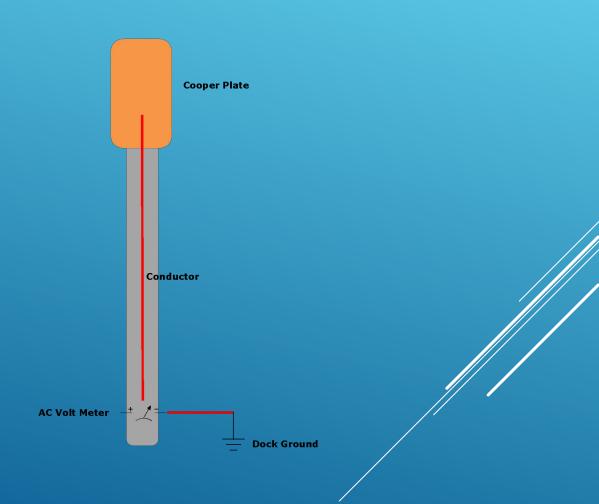
AC VOLTAGE PROBE

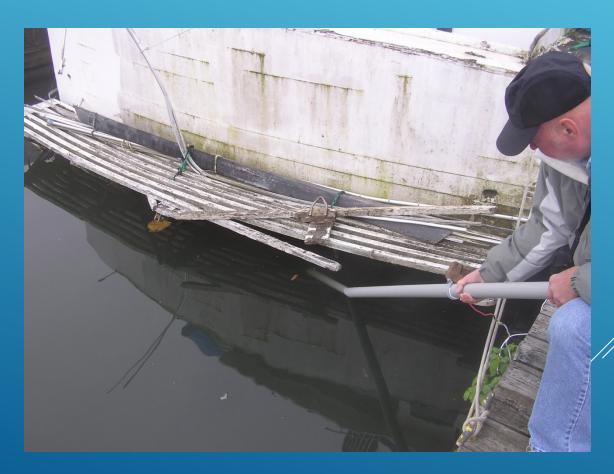
PROBING FOR VOLTAGE 89 VAC 1 FOOT FROM PROPELLER

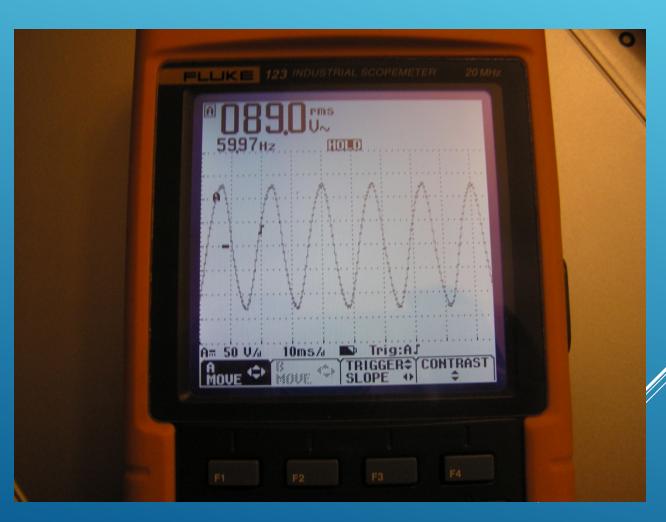
OSCILLOSCOPE READING

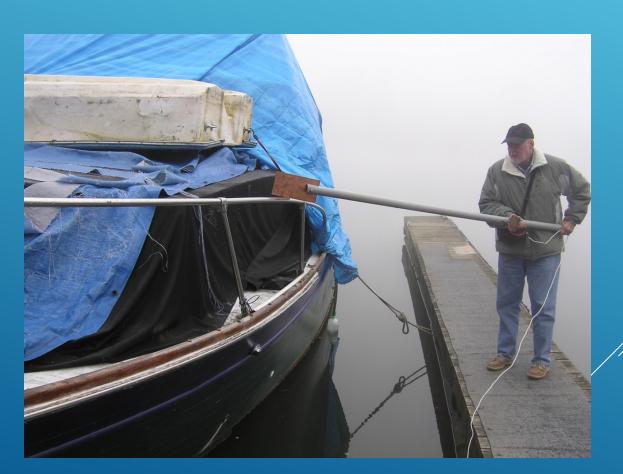
EVERYTHING IS HOT! 24 VOLTS AC ON STANCHIONS

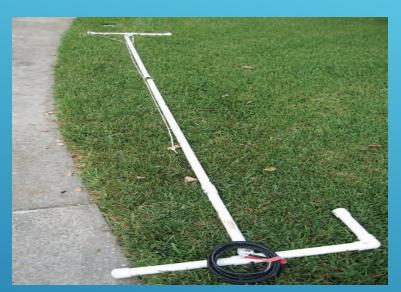
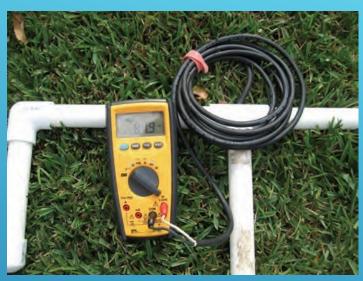
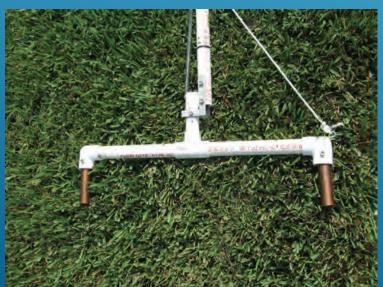
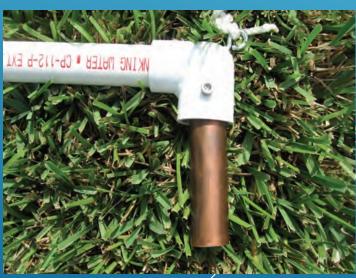
Voltage Gradient Probe

The amount of voltage measured across two given points at a set distance apart.

- Measurement with a multi-meter set to AC volts;
- The closer and more parallel the probe is to the direction of the AC source, the greater the voltage gradient;
- Voltage gradients diminish as the probe moves away from the source.
 Potentially lethal voltage gradient—two volts AC per foot.
 This voltage (2VAC/Ft.) will push 12 milliamps of AC current through the body potentially inducing muscular paralysis.
